# LD-OEM15xx & LD-LRS36xx- Firmware release information 1.X.X

# Update Instructions

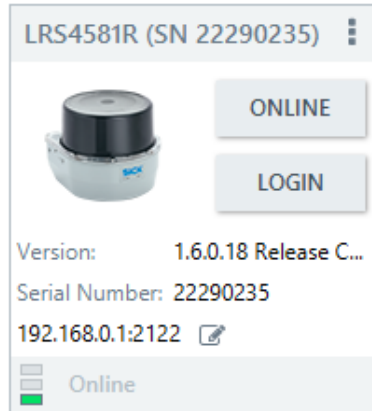
1	Save and unpack the firmware files on your local hard disk (please use full admin rights on your PC).	
2	Make sure your LiDAR is connected via Ethernet to your PC, in the same subnet and booted up. Power supply must remain stable during the update process.	
3	Use SOPAS ET or AppManager for firmware updates. The following instructions refer to SOPAS ET only.	
4	Search for the connected LiDAR and drag and drop the device into the SOPAS project.

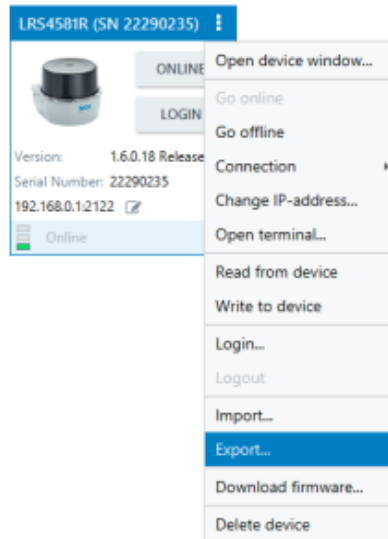
5	Recommendation: Save your parameter file (.sopas file) before you start the update.
