# NAV310 - Firmware release information 1.x.x

# Update Instructions

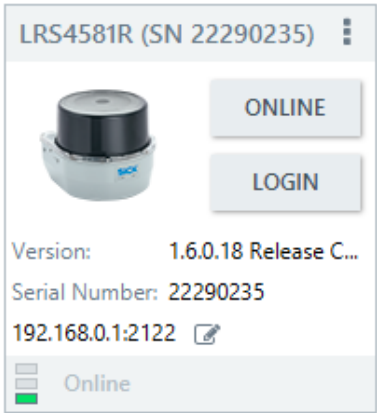
1	Save and unpack the firmware files on your local hard disk (please use full admin rights on your PC).	
2	Make sure your LiDAR is connected via Ethernet to your PC, in the same subnet and booted up. Power supply must remain stable during the update process.	
3	Use SOPAS ET or AppManager for firmware updates. The following instructions refer to SOPAS ET only.	
4	Search for the connected LiDAR and drag and drop the device into the SOPAS project.

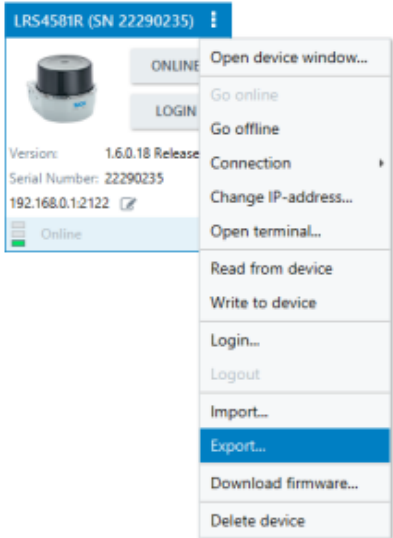
5	Recommendation: Save your parameter file (.sopas file) before you start the update.

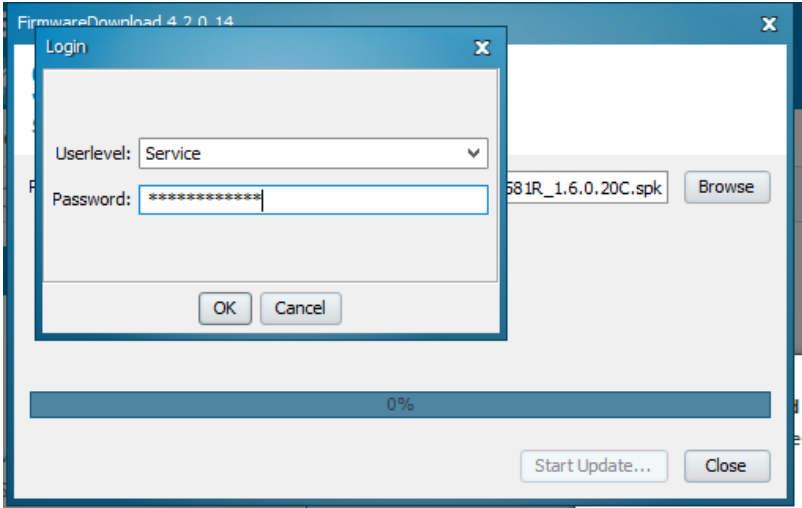
<p>8 Log-in to the LiDAR with user level: <b>Service</b> and password: <b>servicelevel</b></p> <p>The update procedure may take up to 2 minutes.</p>

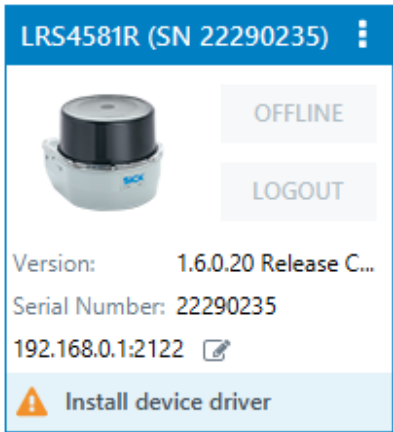
<p>9 Wait until the reboot is completed and the device LED turns green.</p>	
<p>10 Check the SOPAS window for the correct firmware version.</p> <p>Depending on the firmware update, the SOPAS ET device driver may need to be reinstalled by pressing "install device driver".</p>
